CONSTRUCTION MONITORING REPORT

November 2022 to April 2023

Sydney Metro City & Southwest

Package 5 & 6

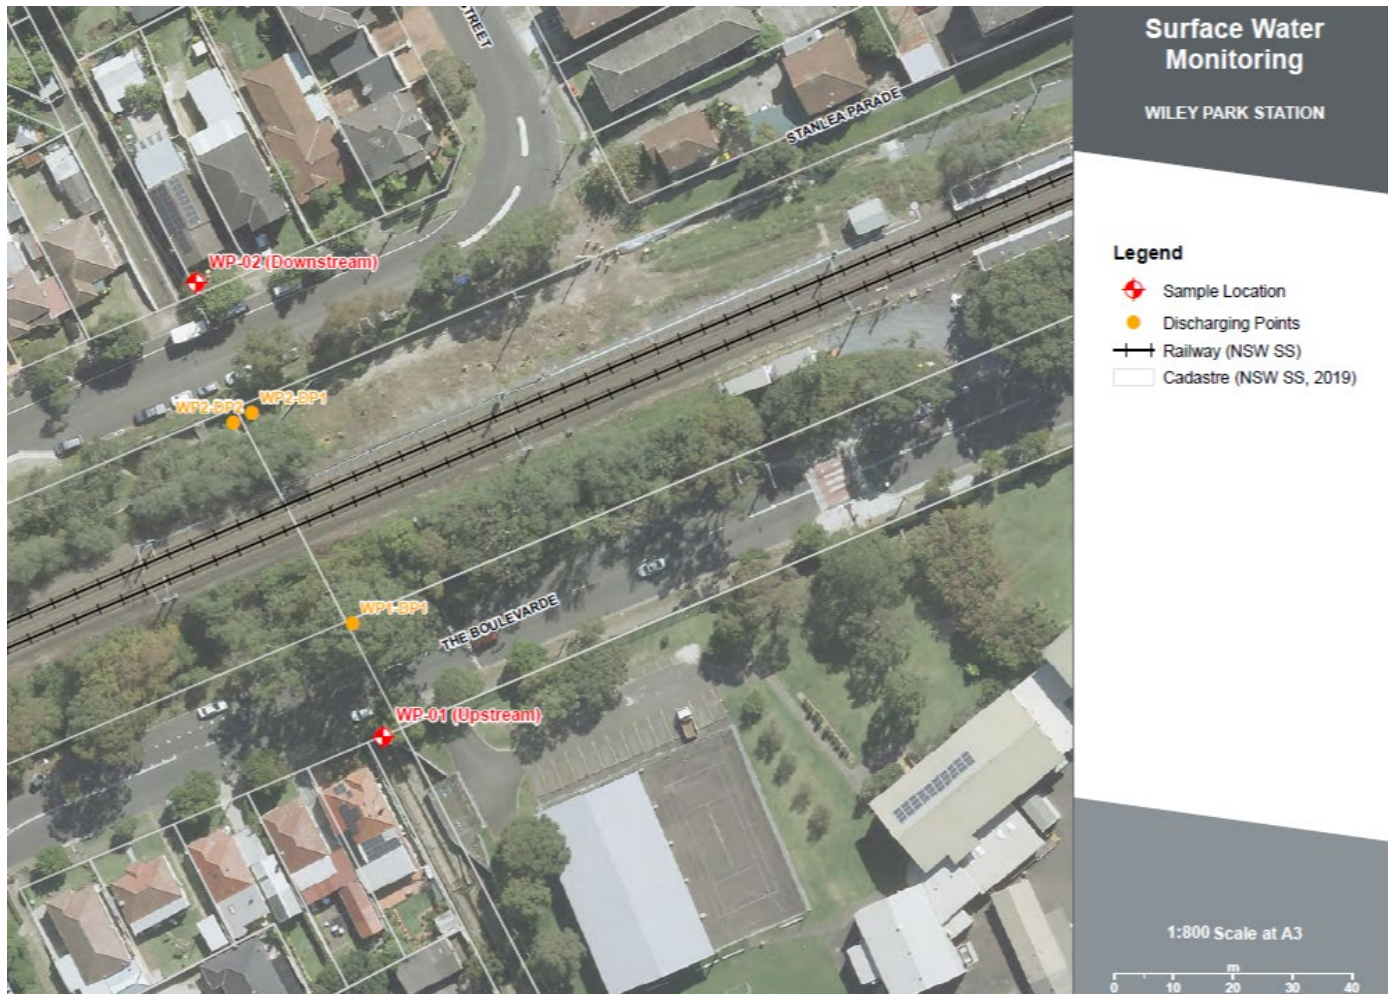
Figure 1: WP1 and WP2 location map. Please note that only WP1-DP1 and WP2-DP1 are Downer's discharge points.

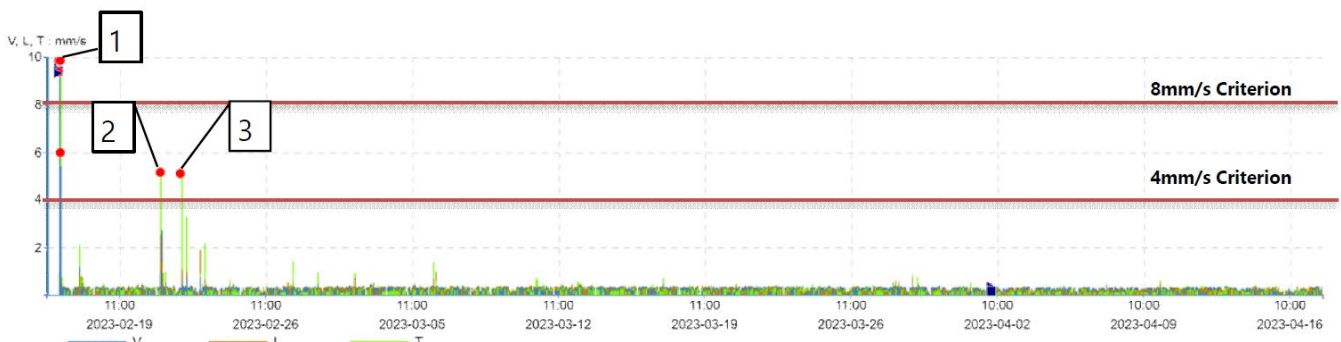
Figure 2 – Unattended vibration monitoring results for 3A Commons Street between 16/02/2023 – 17/04/2023

In accordance with the Hurlstone Park Station Vibration Monitoring Plan, the vibration levels produced from the vibration intensive works in the vicinity of the affected garage structure were below 4 mm/s as shown in Figure 2. Note that there were three events that resulted in an instantaneous vibration level of above 4 mm/s, however this event was not caused by the nearby construction activities, as justified in table below.

Exceedance ID	Date and Time	Cause of exceedance
1	16.02.2023 12:29pm	At this time, the vibration monitor was being installed on the ground spike to commence the vibration monitoring. This exceedance was caused by the RT&A engineer mounting the monitor on the ground spike. No construction activities were occurring at this time.
2	21.02.2023 07:12am	At this time, it was confirmed by the Project team no construction works were occurring near the monitor. An extraneous event such as a worker inadvertently bumping the monitor was likely the cause of the exceedance. Therefore, the exceedance was deemed not construction related.
3	22.02.2023 08:19am	At this time, it was confirmed by the Project team no construction works were occurring near the monitor. An extraneous event such as a worker inadvertently bumping the monitor was likely the cause of the exceedance. Therefore, the exceedance was deemed not construction related.

The results of the unattended vibration measurements were typically below the established vibration screening criterion presented in the CNVS. There were three events that resulted in an instantaneous vibration level above screening criterion that were investigated and found to be unrelated construction activities. The results of the attended vibration measurements show that the measured vibration levels produced by the compacting works were below the established vibration screening criteria for cosmetic damage. Therefore, the risk of cosmetic damage was assessed as low.

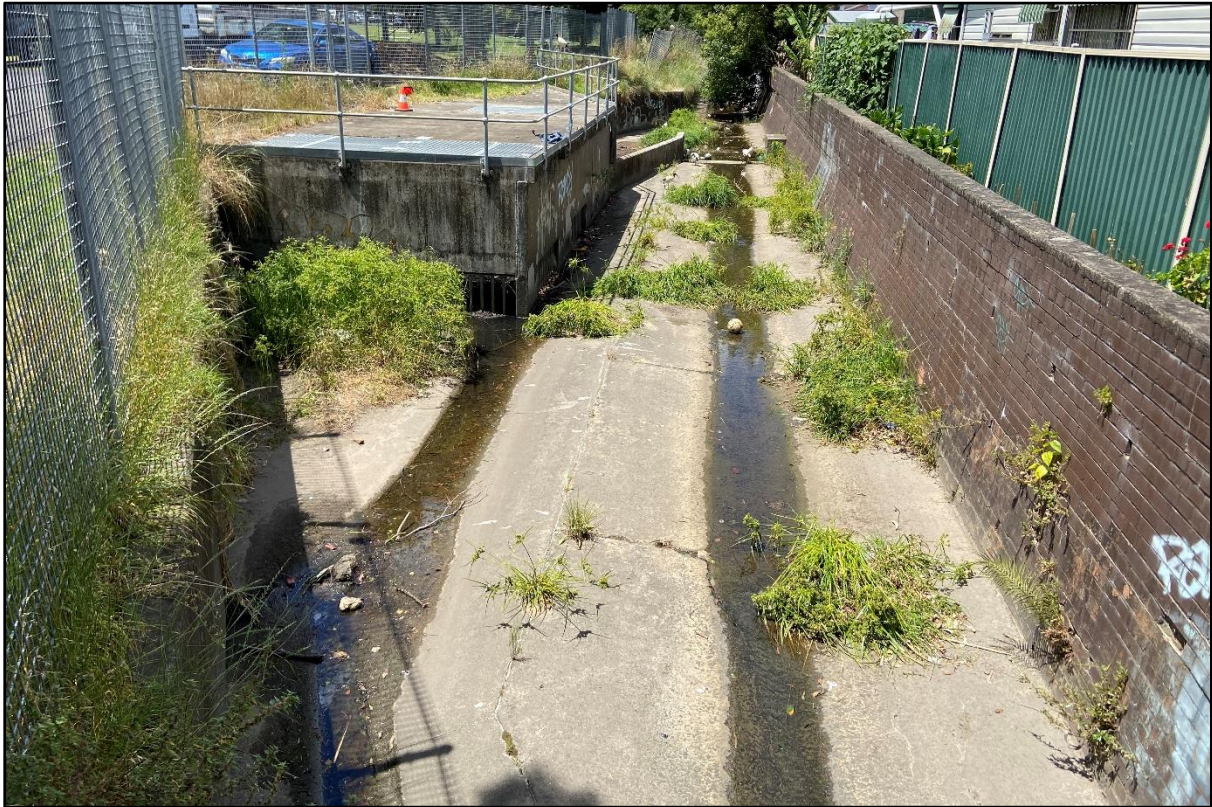
- Observation of water body:
 - WP 1 (upstream of work area) contained low flowing clear water with low turbidity. No visible oil sheen observed from the water surface. The estimated depth of the water body was 0.05 m.

Photograph 1. Condition observed from sampling location of WP1 during the monitoring event – 25 November 2022.

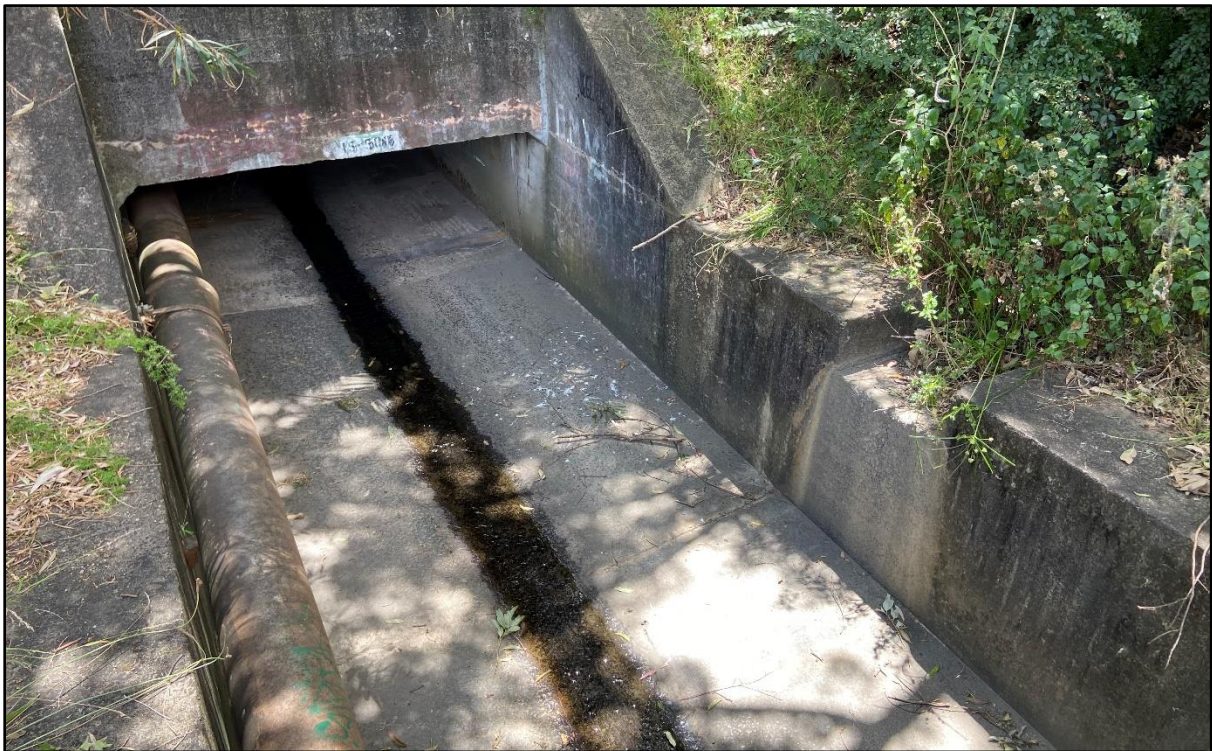
- One discharge point (WP1-DP1) was observed immediately downstream / north of WP1. No flow contribution was observed at the time of sampling. Refer to **Appendix A** for approximate location of WP1-DP1. Refer to **Appendix B** for a detailed photo.

Photograph 2. No stormwater in-flow observed from the discharge point WP1-DP1 which was located within the rail corridor and immediately downstream / north from WP1 during the monitoring event – 25 November 2022.

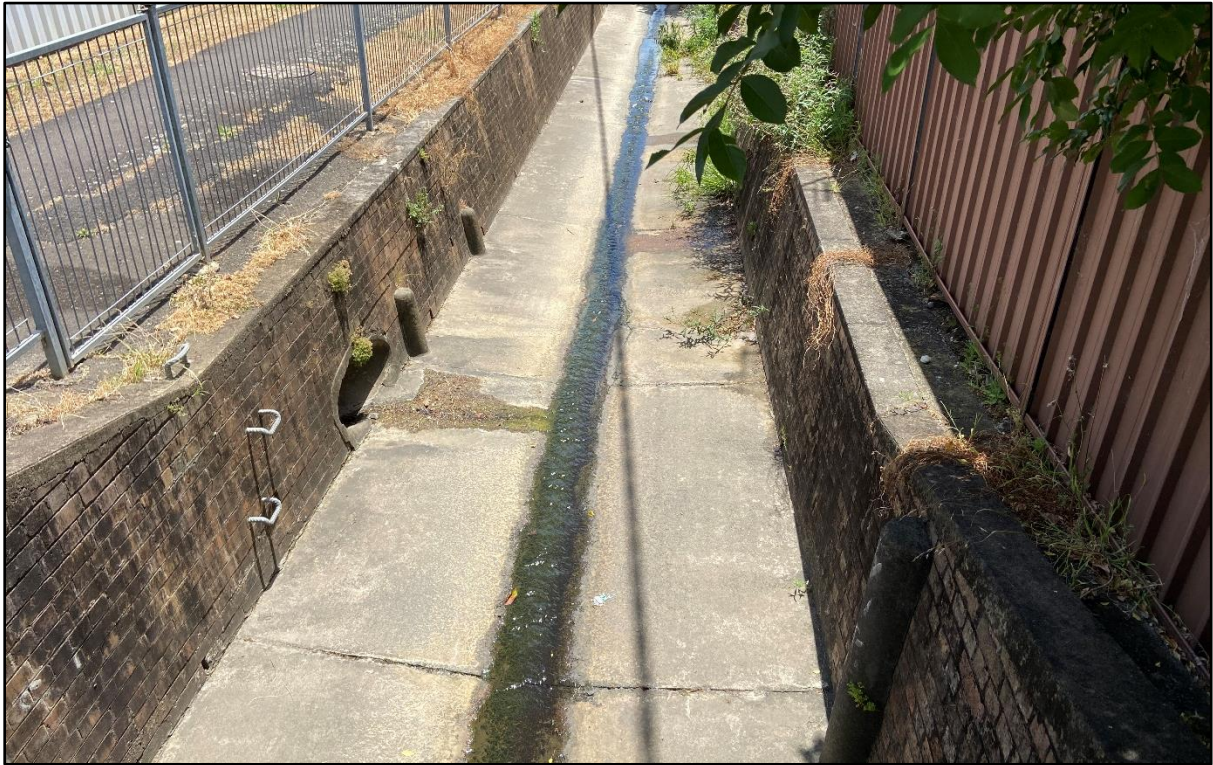
- WP 2 (downstream of work area) contained low flowing clear water with low turbidity. No visible oil sheen observed from the water surface. The estimated depth of the water body was 0.05 m.

- No visible oil sheen observed from the downstream monitoring location (WP2). Refer to **Appendix B** for photos of the surface water condition at the downstream monitoring location.

Photograph 3. Condition observed from sampling location of WP2 during the monitoring event – 25 November 2022.

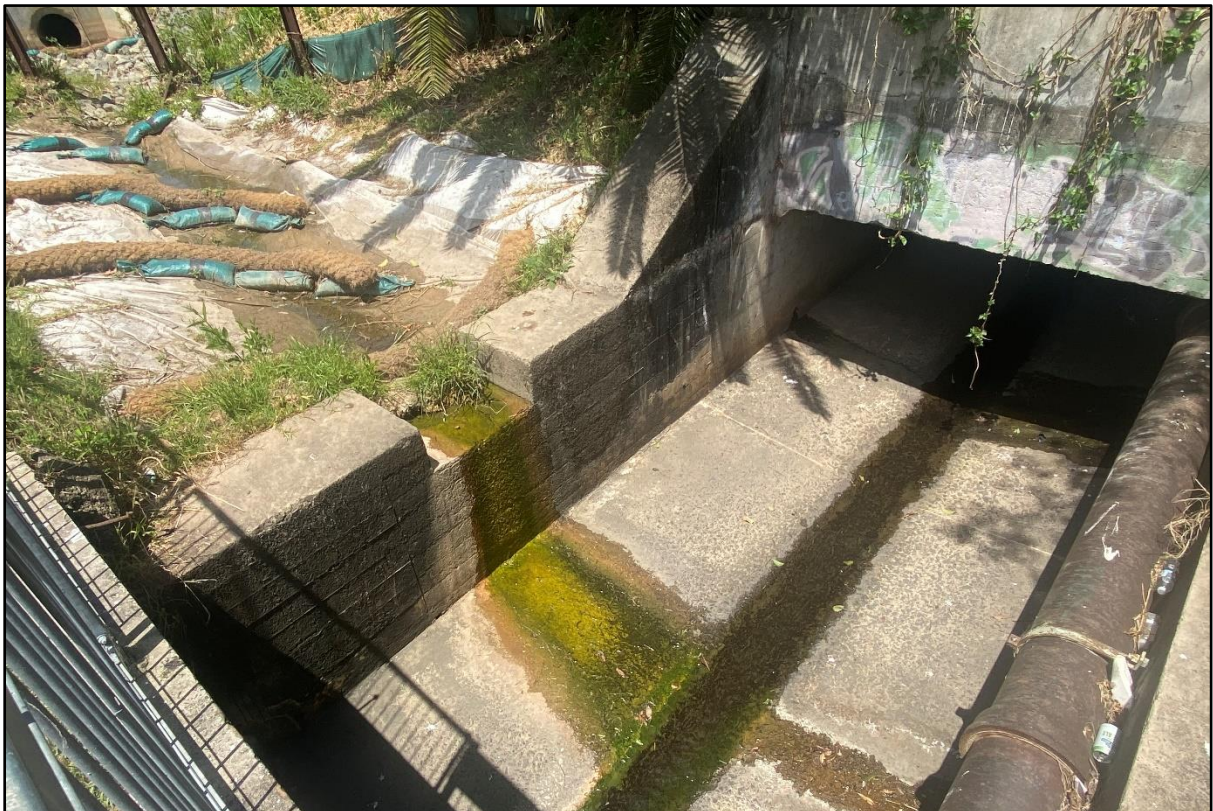
Photograph 4. Minor stormwater in-flow observed from the downstream discharge point WP2-DP1 which were located within the rail corridor and immediately upstream / south from WP2 during the monitoring event – 25 November 2022.

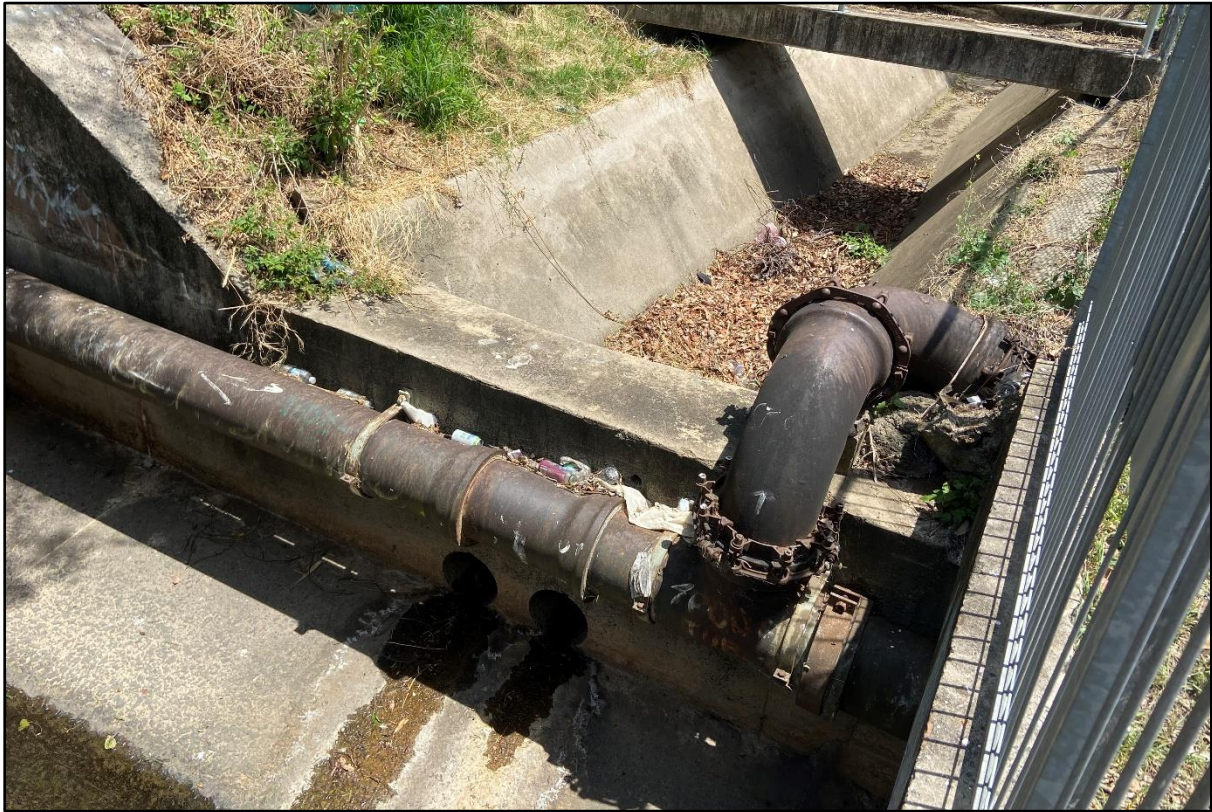
- WP2-DP2 (downstream western discharge point) was dry. No contribution to the water body was observed during the time of sampling.
- Additional observation:

Photograph 5. No stormwater in-flow observed from the downstream discharge point WP2-DP2 which were located within the rail corridor and immediately upstream / south from WP2 during the monitoring event – 25 November 2022.

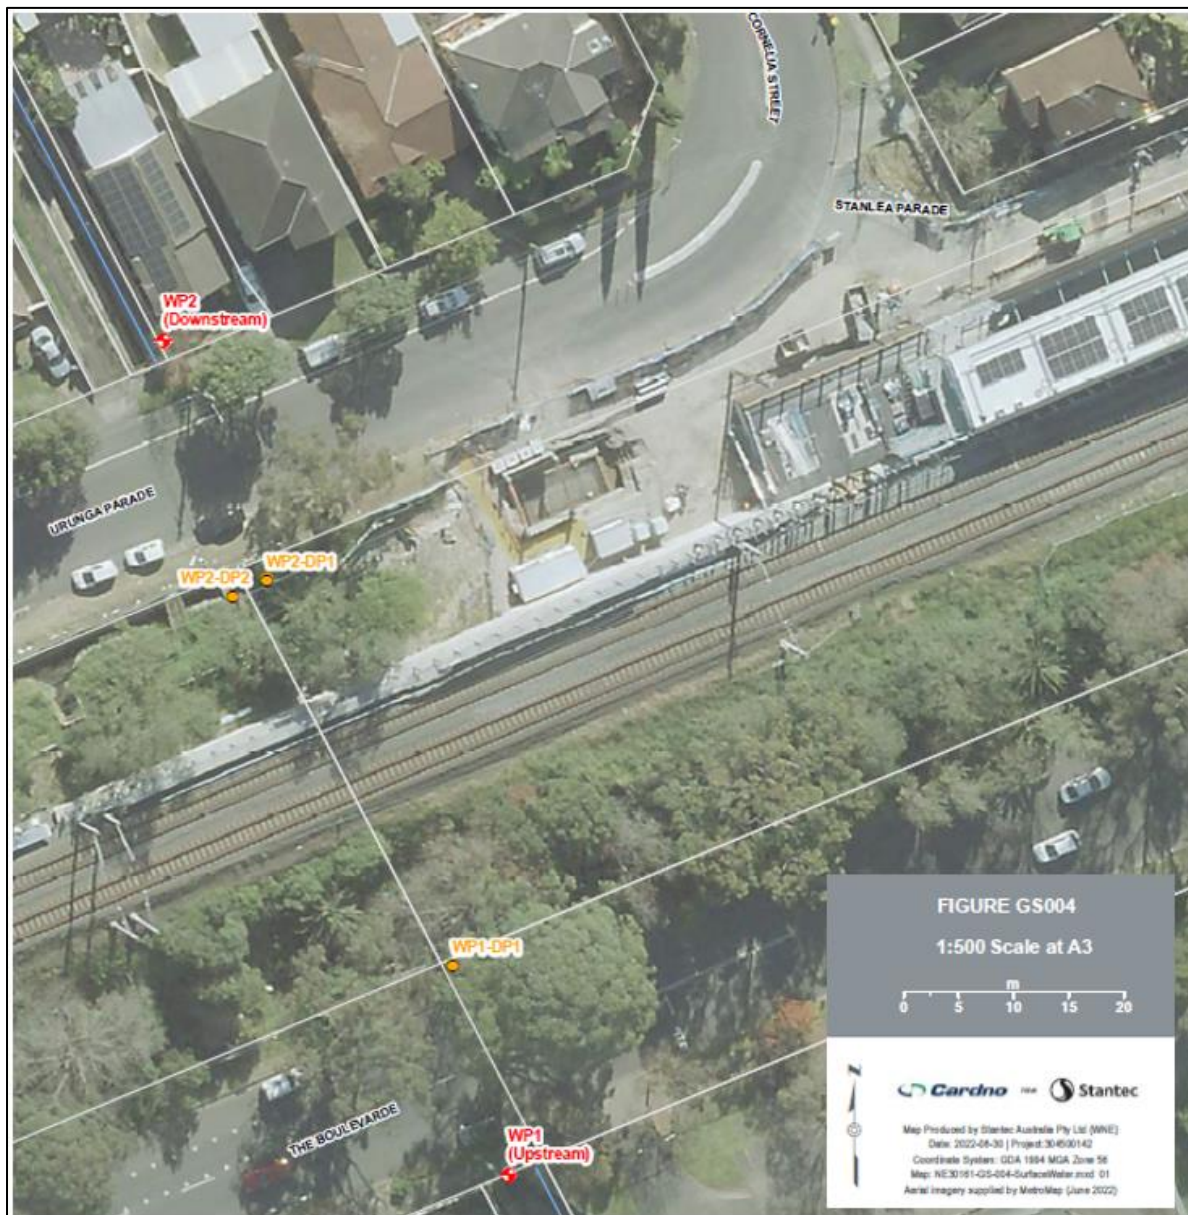
Figure 3-1 Monitoring Locations

The monitoring locations are presented on **Figure 3-1** (refer to **Appendix A** for a full-size figure).

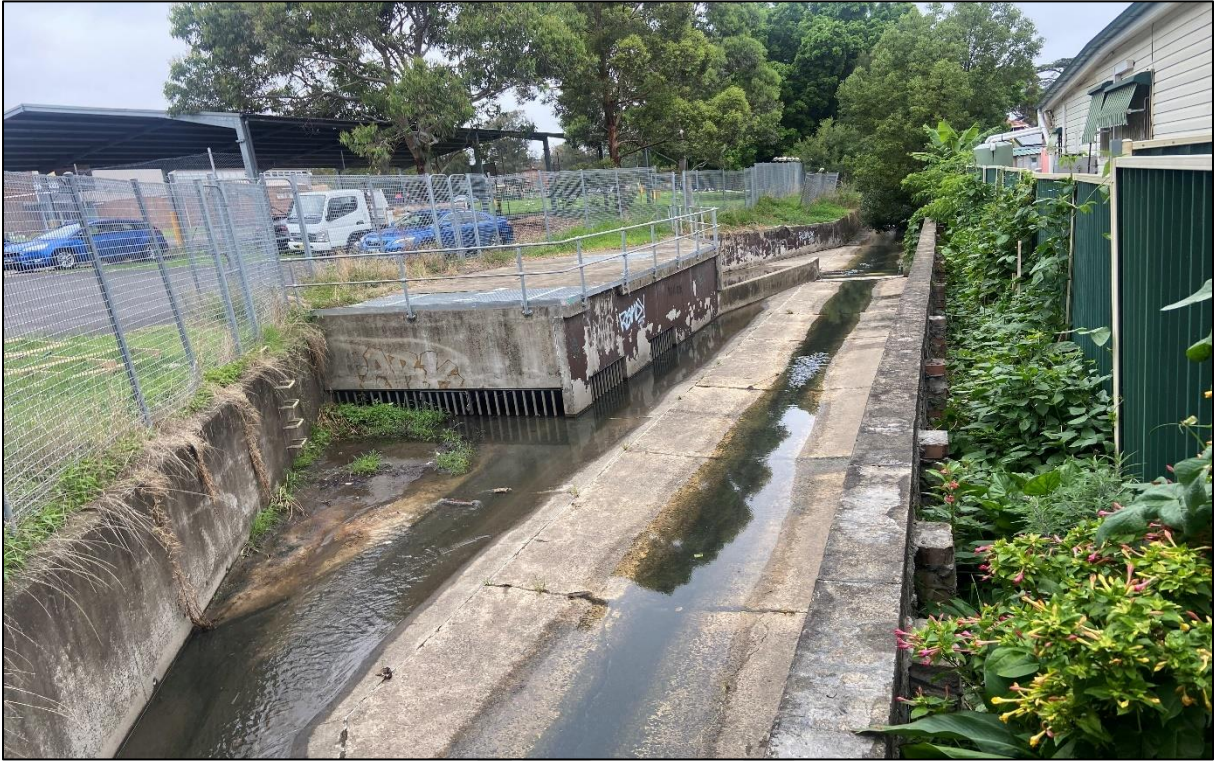
Photograph 1. Condition observed from sampling location of WP1 during the monitoring event – 22 February 2023.

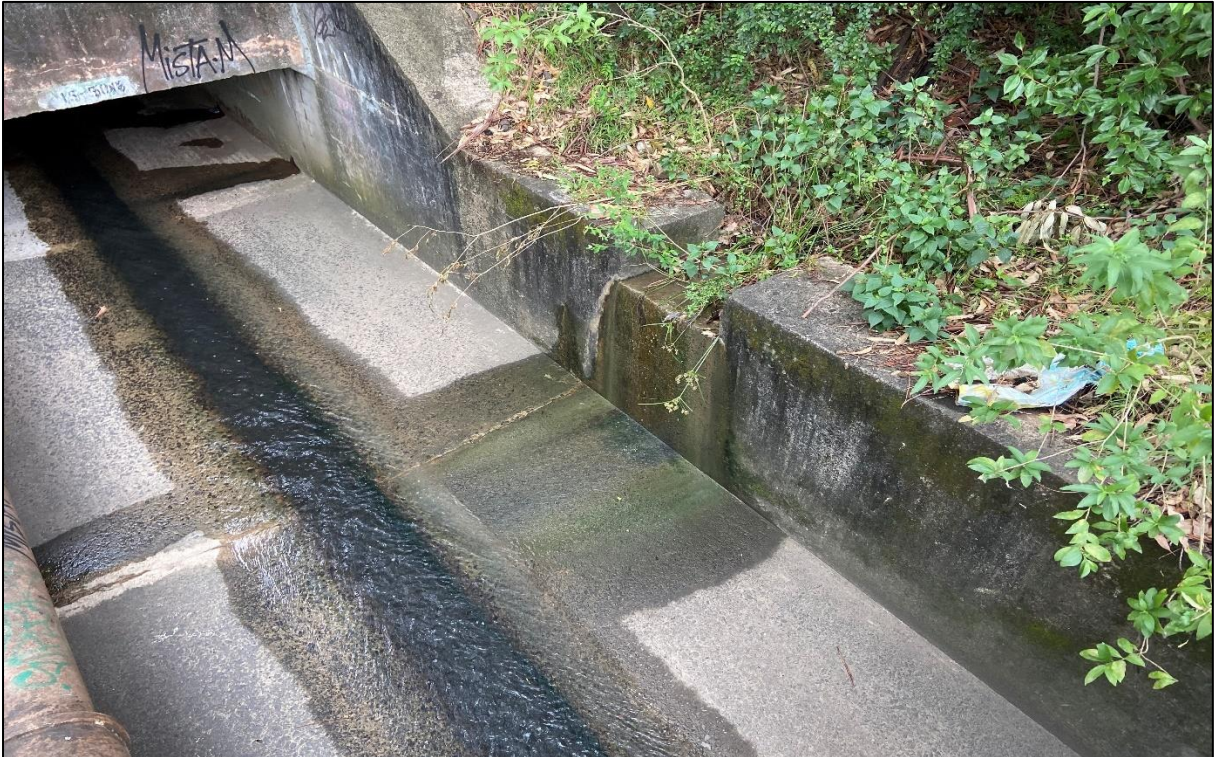
Photograph 2. Low stormwater in-flow observed from the discharge point WP1-DP1 which was located within the rail corridor and immediately downstream / north from WP1 during the monitoring event – 22 February 2023.

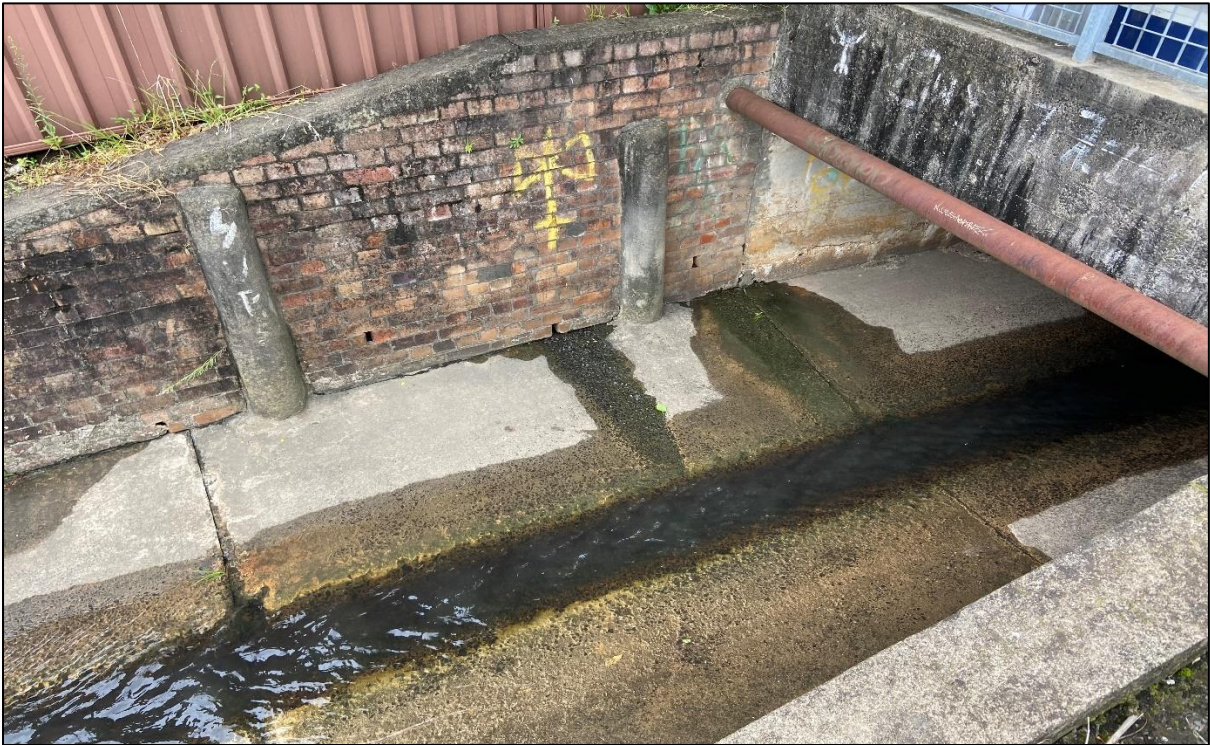
Photograph 3. Condition observed from sampling location of WP2 during the monitoring event – 22 February 2023.

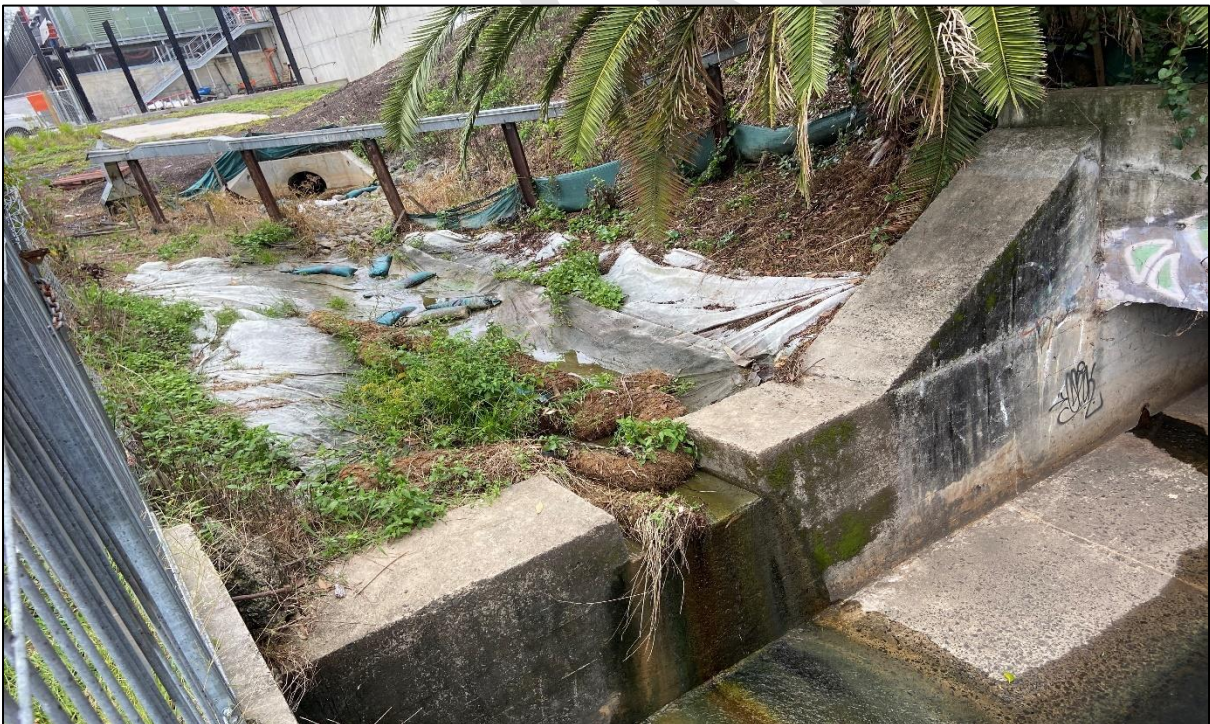
Photograph 4. High flow stormwater observed from the downstream discharge point WP2-DP1 which were located within the rail corridor and immediately upstream / south from WP2 during the monitoring event – 22 February 2023.

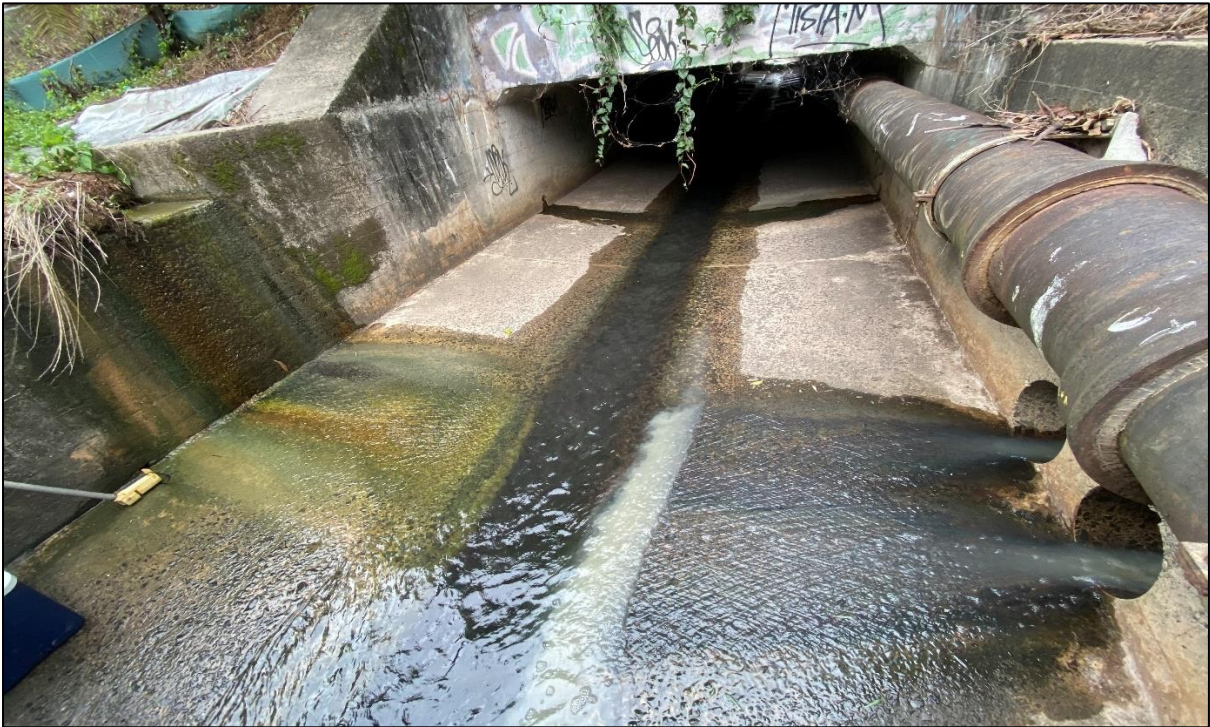
Photograph 5. High flow stormwater observed from the downstream discharge point WP2-DP1 which were located within the rail corridor and immediately upstream / south from WP2 during the monitoring event – 22 February 2023.

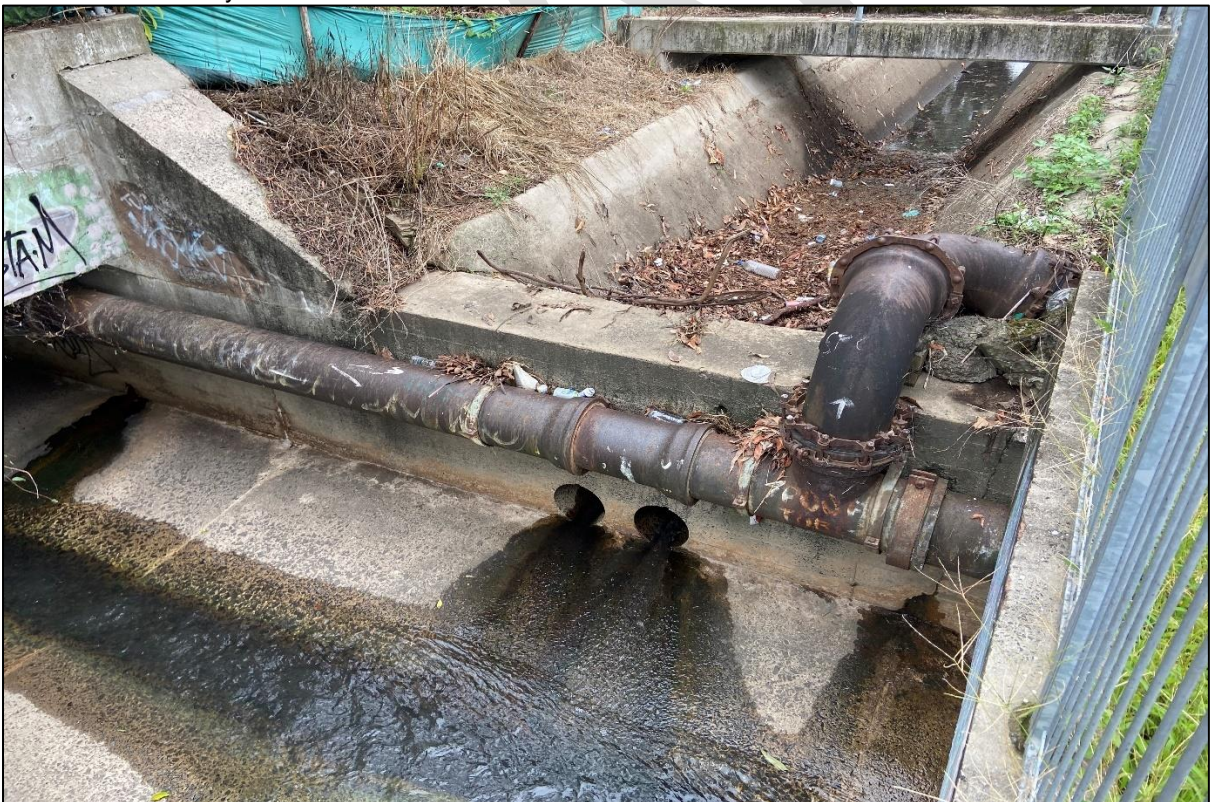
- The stormwater discharged from WP2-DP2 discharge point was not from the Wiley Park Station Upgrade worksite.
- The increased level of turbidity was potentially caused by the disturbance of sediment in the WP2-DP2 discharge point by the light rain and wind during sampling.

Photograph 6. High flow stormwater observed from the downstream discharge point WP2-DP2 which were located within the rail corridor and immediately upstream / south from WP2 during the monitoring event – approximately 1:30 pm 22 February 2023 (before sampling).

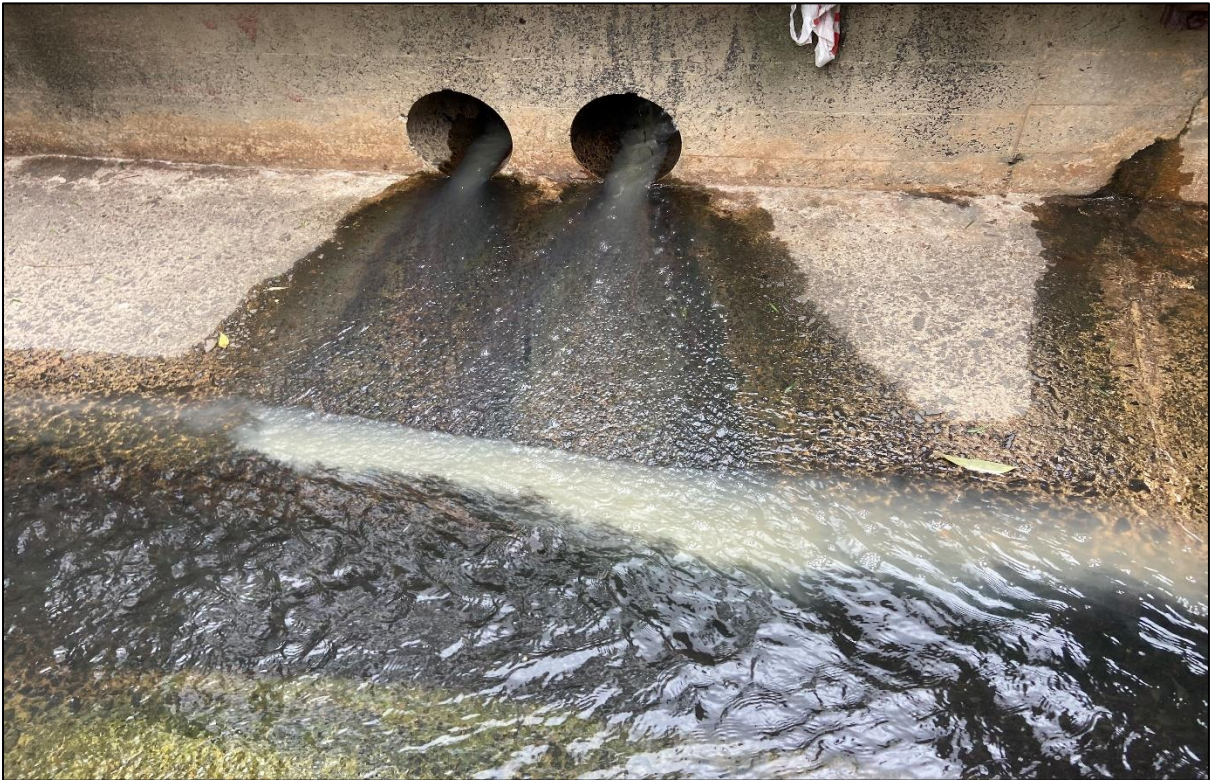
Photograph 7. High flow stormwater observed from the downstream discharge point WP2-DP2 which were located within the rail corridor and immediately upstream / south from WP2 during the monitoring event – approximately 2:30 pm 22 February 2023 (at the time of sampling).

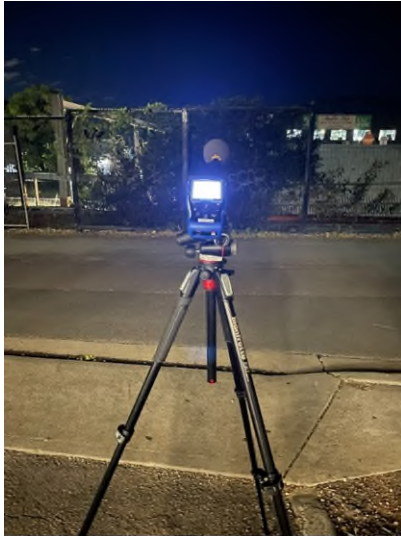
Figure 2-1: Noise monitoring setup

Noise measurement equipment consisted of one NTi Audio XL2 Type 1 sound level meter and microphone calibrator. The microphone was checked prior and after measurements using a Bruel & Kjaer Type 4231 calibrator. No significant drift in calibration was observed. All instrumentation complies with AS IEC 61672.1 2004 '*Electroacoustics – Sound Level Meters*' and carries current NATA certification (or if less than 2 years old, manufacturers certification).

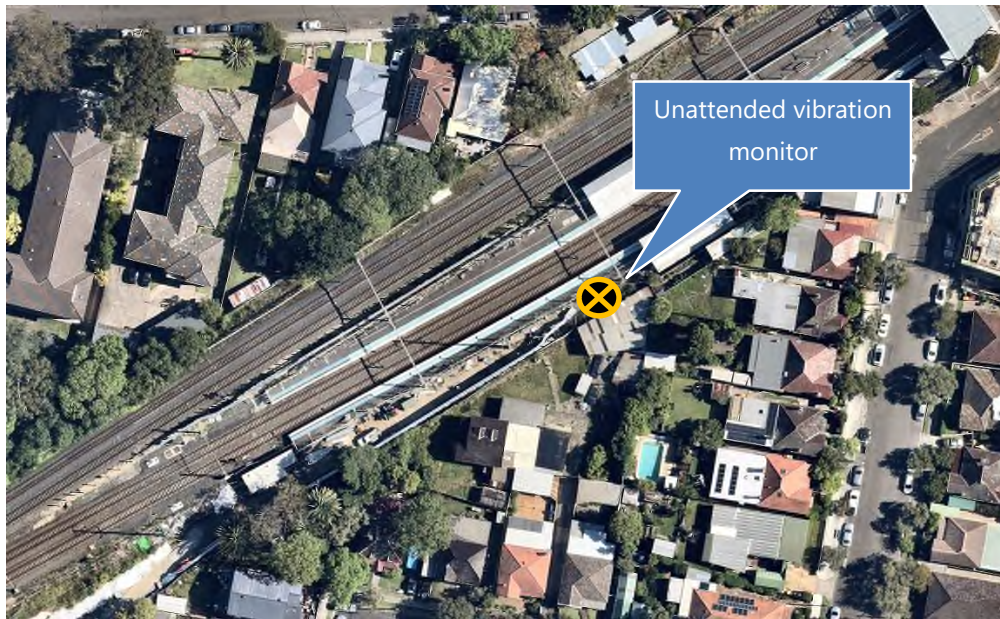
Figure 2-1: Vibration monitoring location

The monitoring location is shown in Figure 2-1. Photos depicting the monitoring location are also included in APPENDIX A.

The vibration monitor was installed as close as possible to the foundation of the garage structure at 3A Commons Street, assessing cosmetic damage. For monitoring on soils, in accordance with AS 2775-2004¹, a ground spike was planted into the surface and the accelerometers were mechanically mounted onto the ground spike.
