ENVIRONMENT PROTECTION LICENCE NO: 21029

March 2019 Monthly Report

**Princes Highway Upgrade
between Berry and Bomaderry**

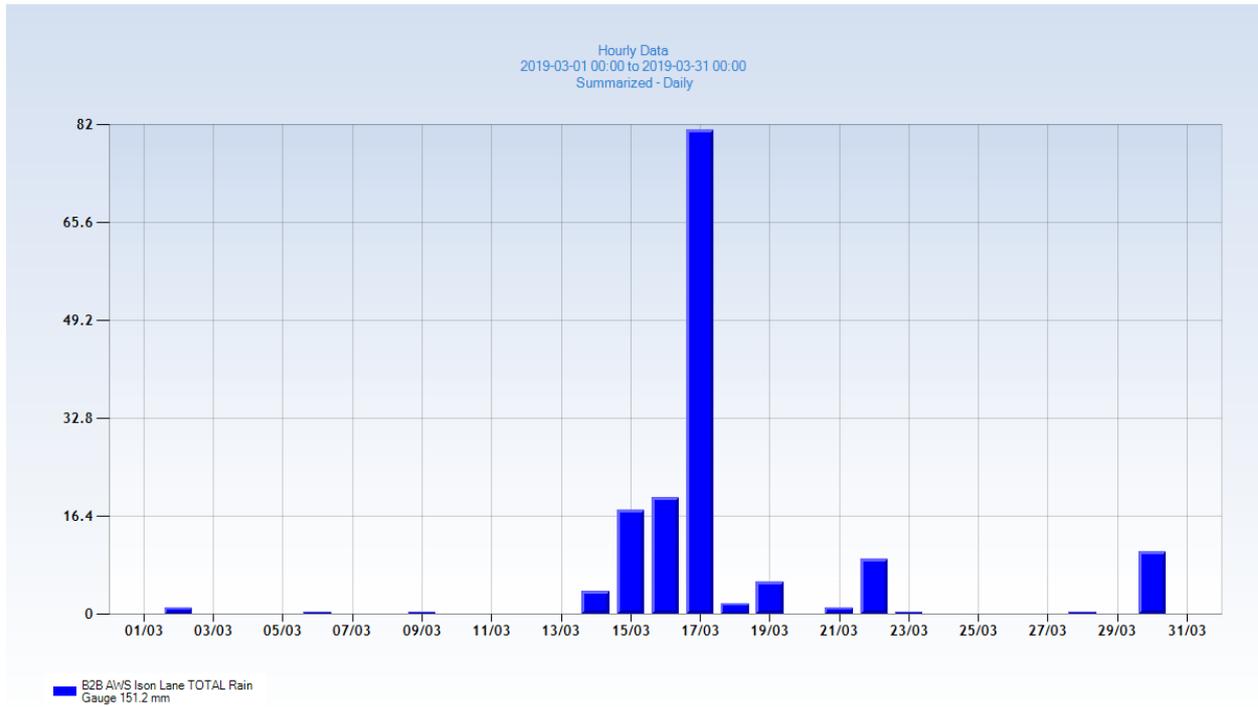
Figure 3-2 March Rainfall Results Ison Compound Weather Station

During March 2019 six rainfall events were recorded at the project specific weather station (Ison Lane, Jaspers Brush (RMS automatic weather station)). The largest rainfall event was on Sunday the 17th of March during which 80.2mm of rainfall was recorded. This was a high intensity event with 70.4mm falling within a six-hour period, corresponding to an average recurrence interval (ARI) of 2 years for a six-hour storm duration.

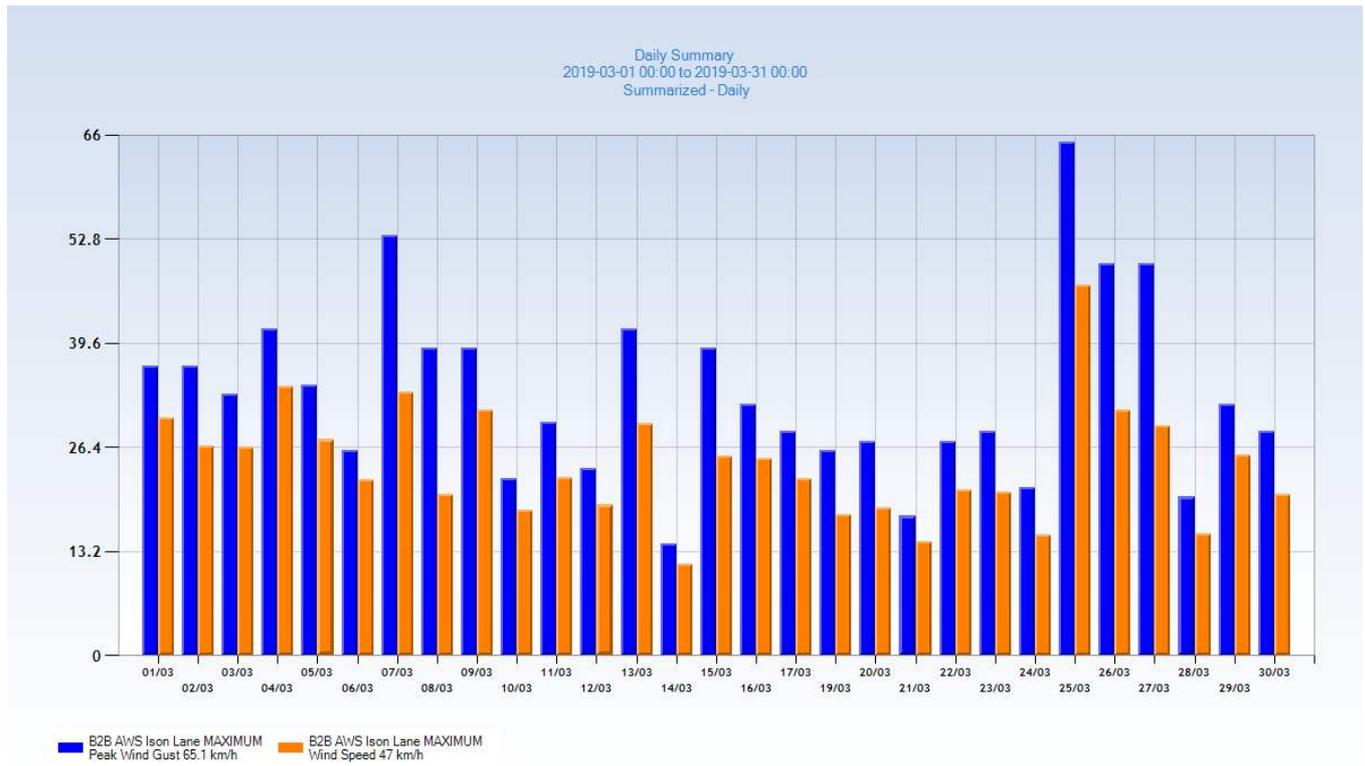
Figure 3-3 March 2019 Wind Results Isons Compound Weather Station

During March the predominant wind was from the South. The highest wind gust recorded was 65.1 km/h and maximum wind speed was 47.0 km/h (refer Figure 3-3). DSWJV continue to monitor site activities, implement dust suppressant across the site and utilise a fleet of water carts during working hours.

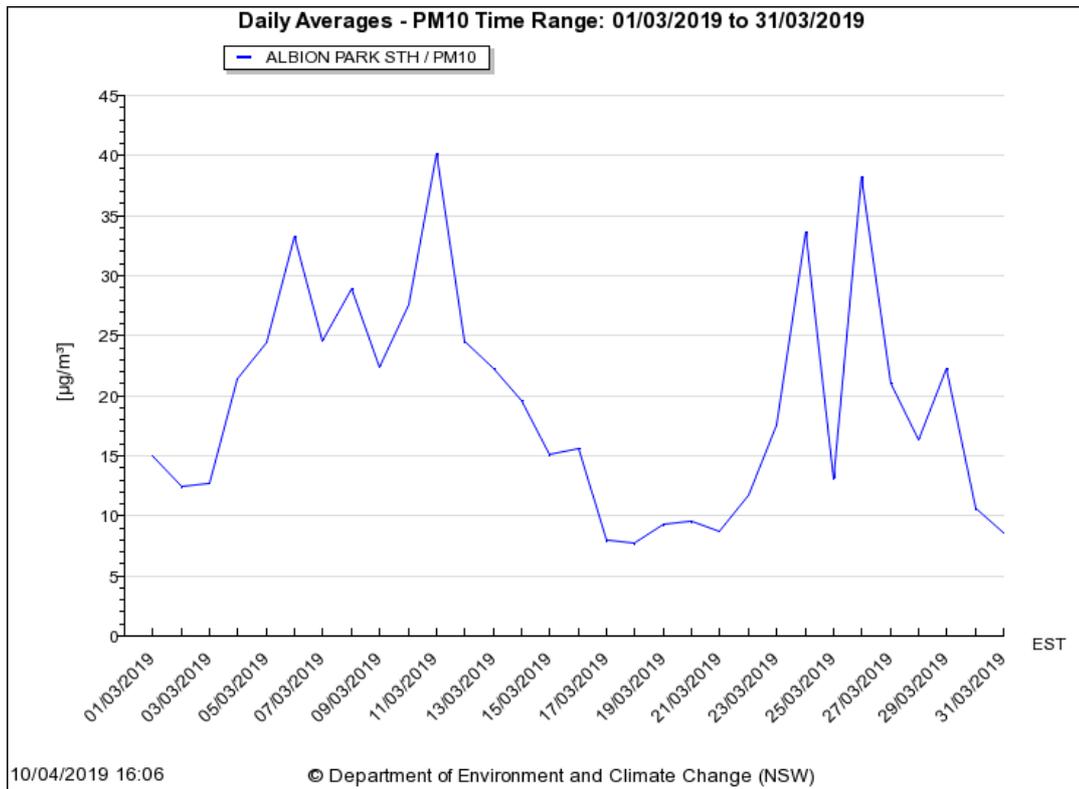
Figure 5-1 - Daily Average PM10 levels at Albion Park South NSW Air Quality Monitoring Station, courtesy of NSW Office of Environment and Heritage

Figure 5-1 provides air quality data at the nearest OEH ambient air quality monitoring station to the project (Albion Park, approximately 25 km north of the project area).
